**MARYLAND HISTORICAL TRUST  
DETERMINATION OF ELIGIBILITY FORM**

QA-126  
Hiram Hammond Farm  
Wye Mills vicinity  
Private

## INVENTORY FORM FOR STATE HISTORIC SITES SURVEY

Hiram Hammond farm

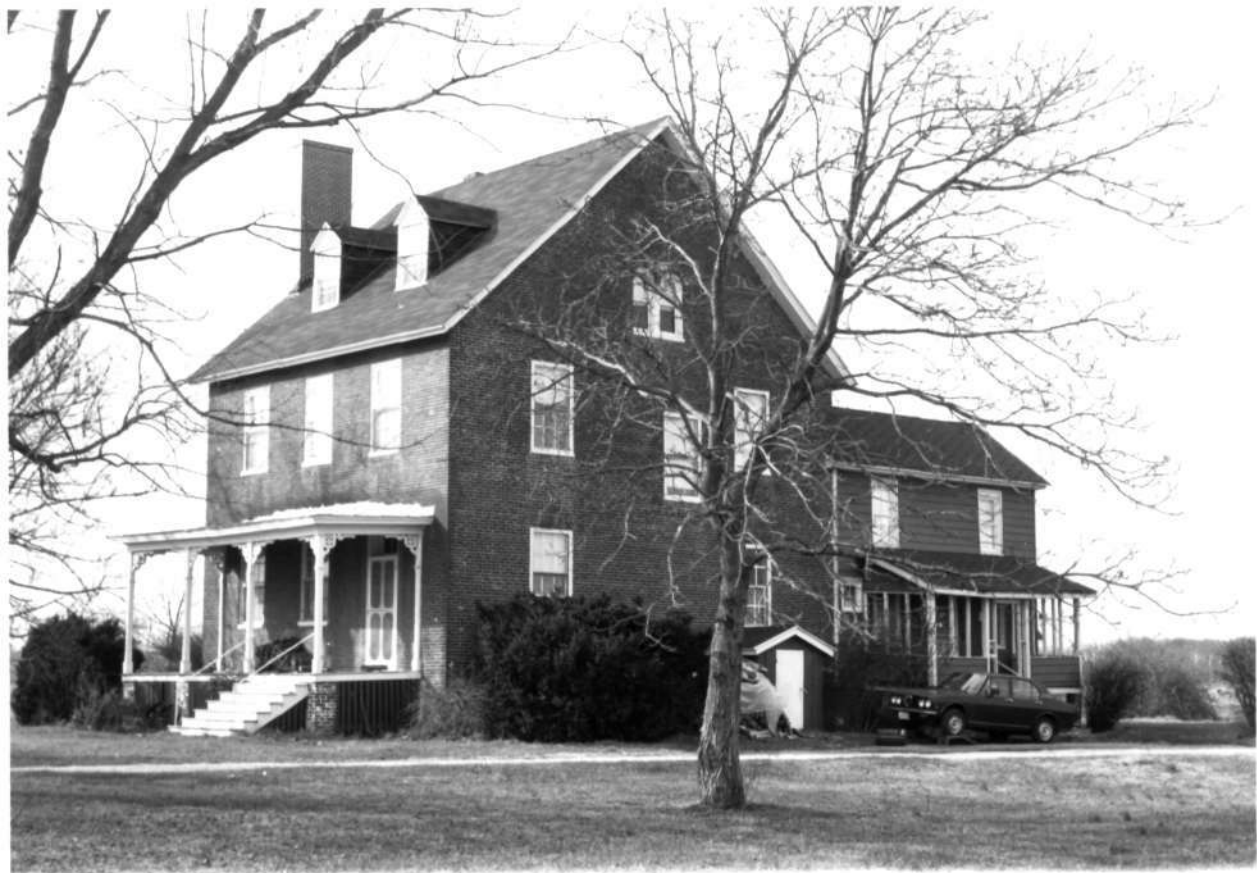
QA-126 Hiram Hammond Farm  
Wye Mills vicinity  
Orlando Ridout V 1981  
View from Southeast

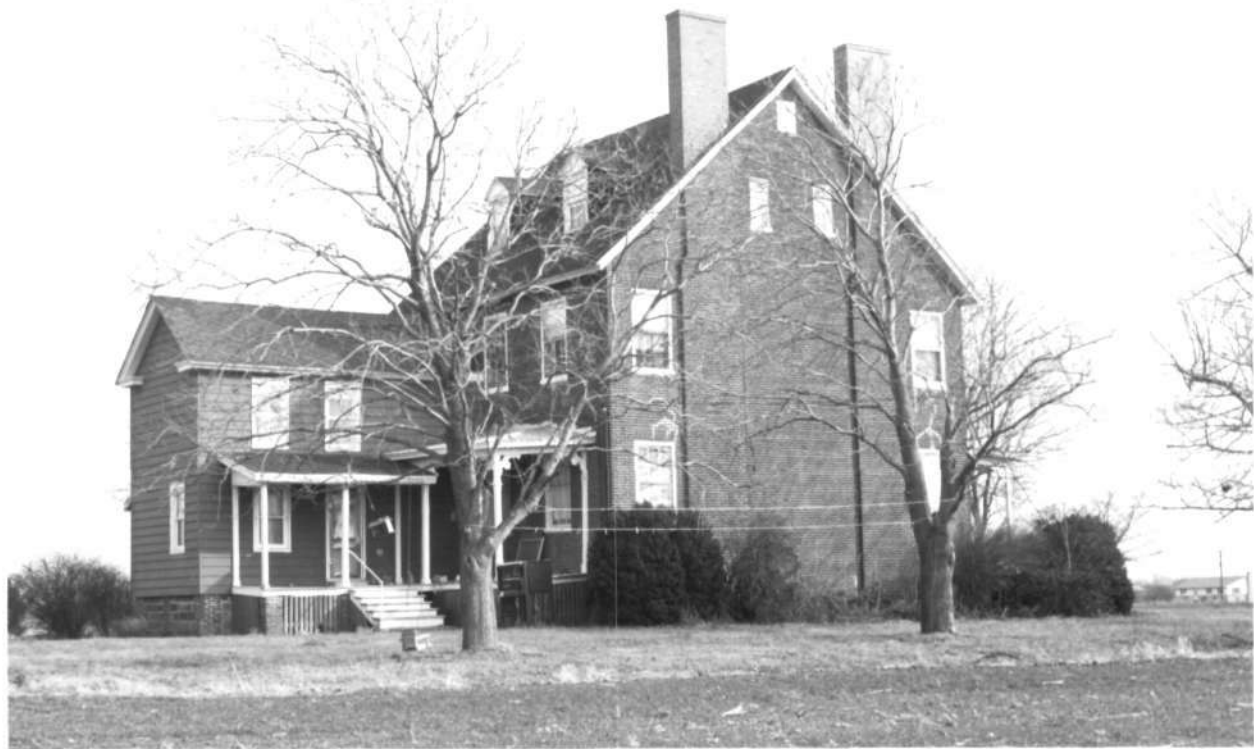
QA-126 Hiram Hammond Farm  
Wye Mills vicinity  
Orlando Ridout V 1981  
View from Northwest

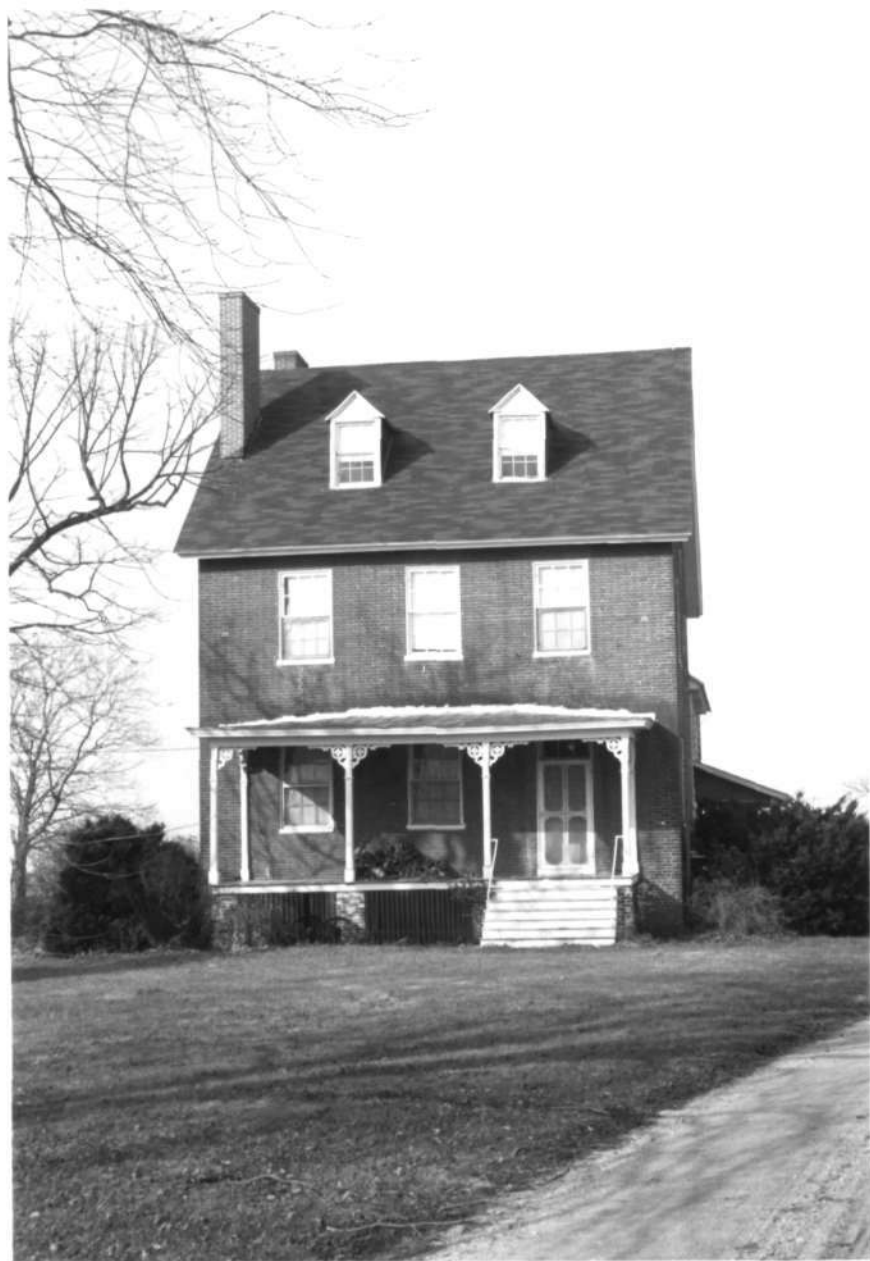
QA-126    Hiram Hammond Farm  
          Wye Mills vicinity  
          Orlando Ridout V    1981  
          Front (southeast) facade

The front facade faces south, toward Wye Mills. It is carefully ordered, with the entrance in the east bay on the first floor and two six-over-six windows to the left of the door, three six-over-six windows on the second floor, and a pair of six-over-six pitched roof dormers on the third floor. Three-over-three cellar windows are located directly below all three first floor openings. The paneled entrance door is set in an opening with paneled soffit and jambs, and is further enhanced by a three-light transom. The outline of an early entrance

porch remains visible, but this was replaced in the late 19th century with an open one-story porch with chamfered and bracketed posts. This porch stretches across all three bays on the first floor. The brickwork on this facade is laid in Flemish bond above a five-course bond foundation. The window openings have splayed brick jack arches, and a corbeled brick cornice is still visible, though now partially hidden by a modern box cornice.

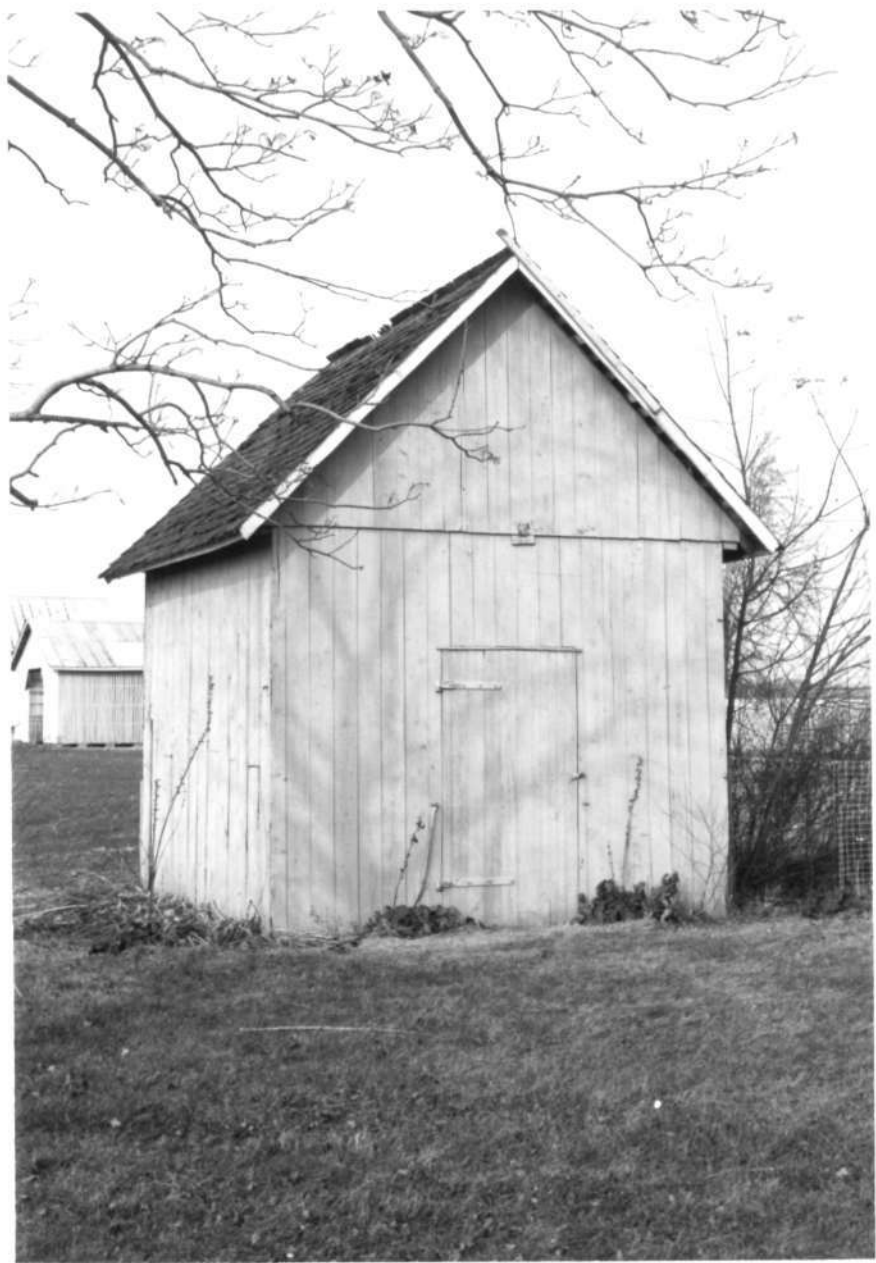
QA-126   Hiram Hammond Farm  
          Wye Mills vicinity  
          Orlando Ridout V   1981  
          Meat House

To the rear of the house stands a very fine smokehouse with closely set heavy timber framing. Inside the meat house is a large curing barrel that was evidently put in place before the building was constructed or was made in place, as it is too large to pass through the door of the building. This is the only curing barrel recorded in the county.
